Brynmenyn Hydrogen Plant

Phase I Desk Study

2022-07-20

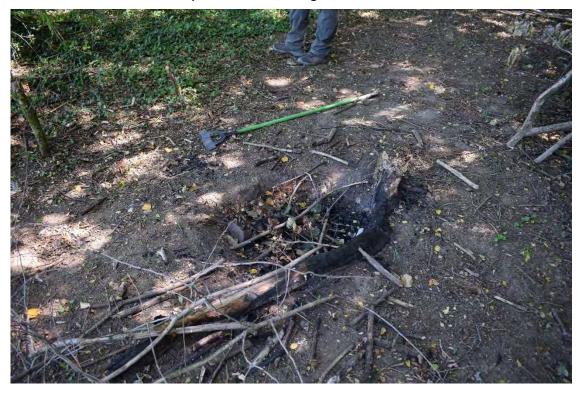
Photo 9: Shows evidence of previous fires and garden tools close to the "den".

Within the trees forming the southern boundary of the development area a temporary camp was identified formed using scrap wood and plastic sheeting, with a number of garden tools, broken glass, and general detritus in the vicinity.

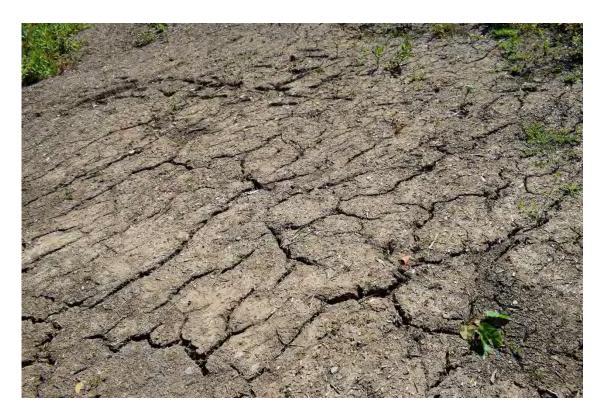
Photo 10: Shows desiccation cracks seen near site entrance

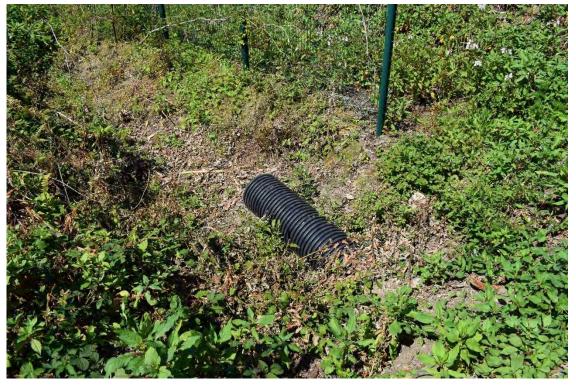
Photo 11: Shows drain running under path at entrance to site.
